McGlynn Laboratories Inc.
Report of Hydrological Results
Bayou Point

For: Bayou Point, Calloway, FL.

Report Date: Wednesday, May 1, 2006

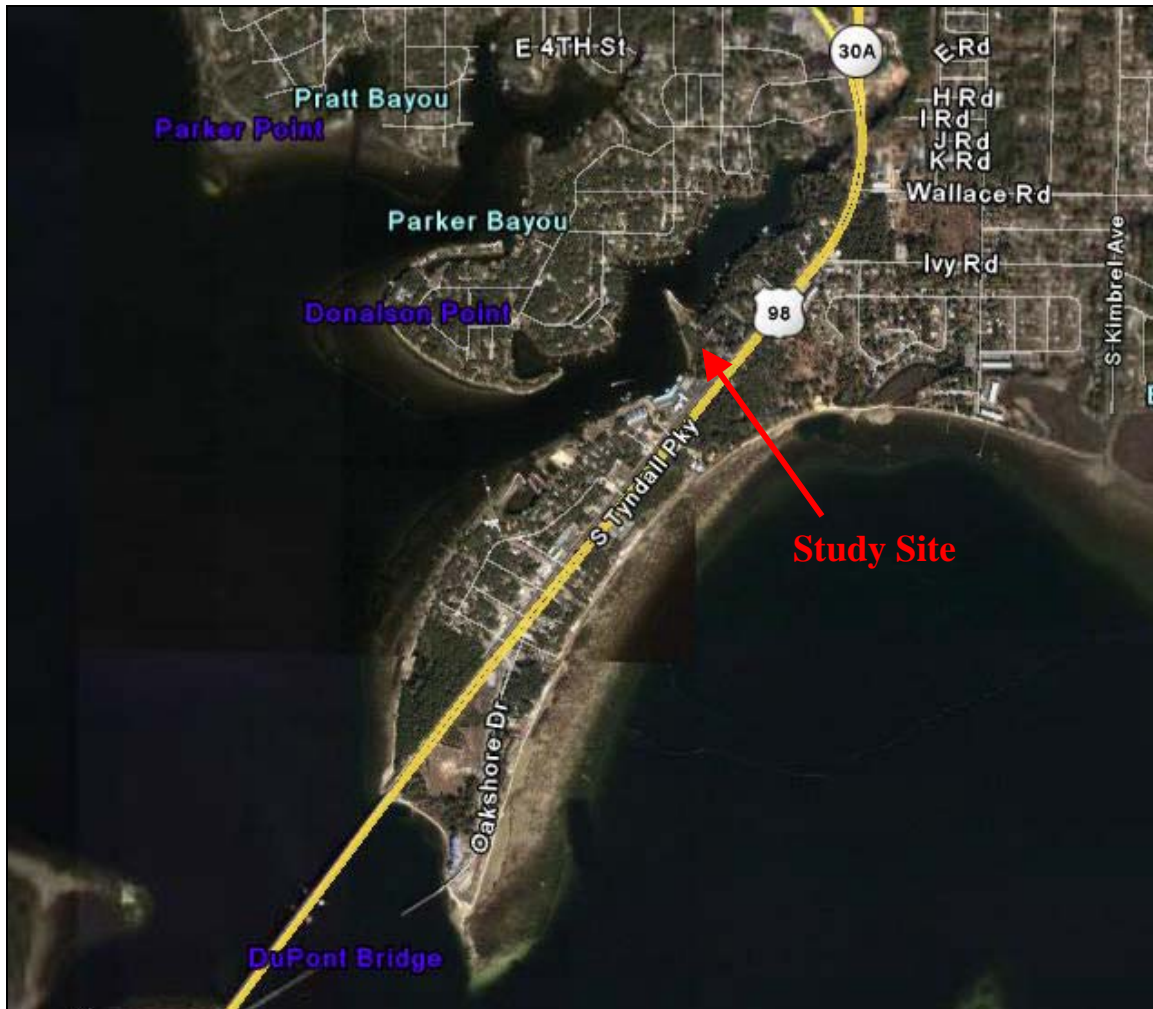
Figure 1: Satellite imagery of the Bayou Point site located near Calloway, Florida. It is located between Donalson Point and Long Point. Bayou Point empties into East Bay near the DuPont Bridge across the Bay from Tyndall Air Force Base.

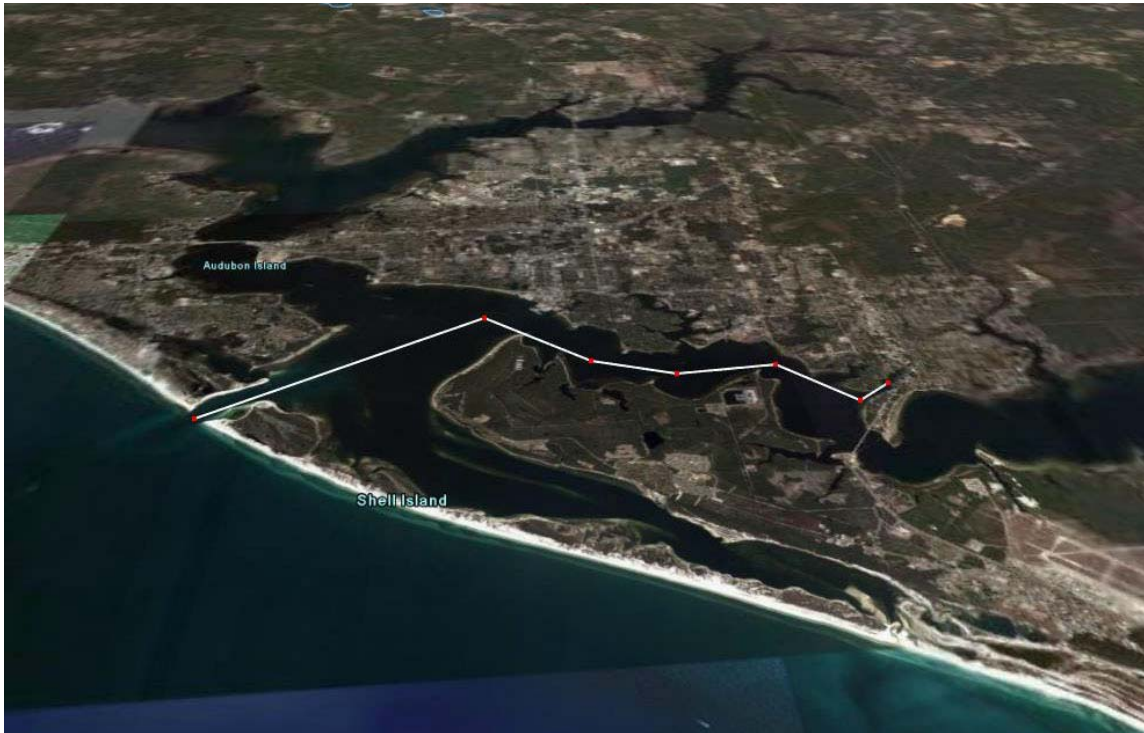
Figure 2: Satellite imagery of the Bayou Point site (near Calloway, Florida). Bayou Point empties into East Bay, joins St. Andrews Bay and empties into the Gulf of Mexico at the pass near Grand Lagoon, approximate 9.72 miles from the Gulf of Mexico by water.

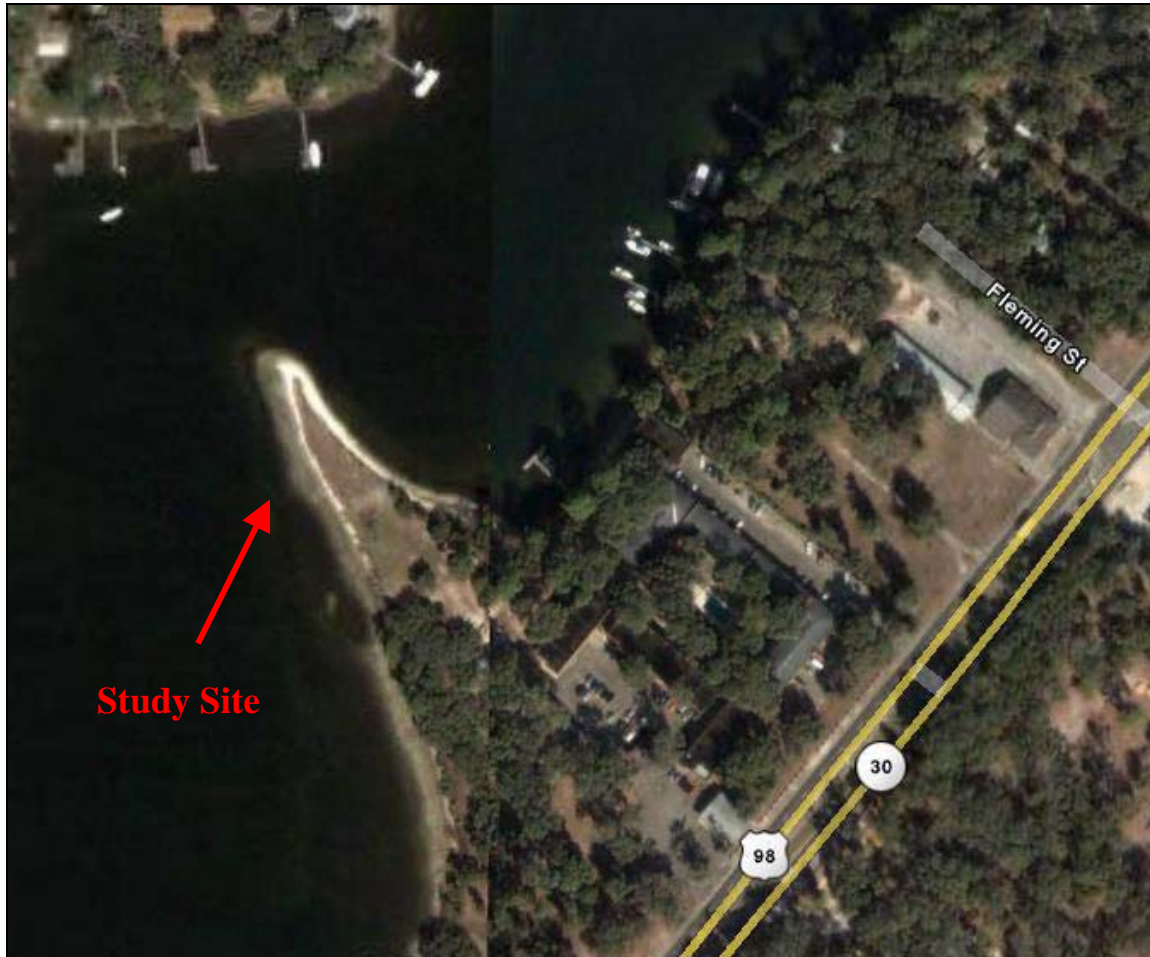
Figure 4: The study site is located on a peninsula located at the approximate mid-point of the Bayou, 0.6 miles from the headwaters of the Bayou and 0.58 miles from open water in East Bay. The Bayou is 0.11 miles wide where the peninsula extends 0.06 miles into the Bayou.

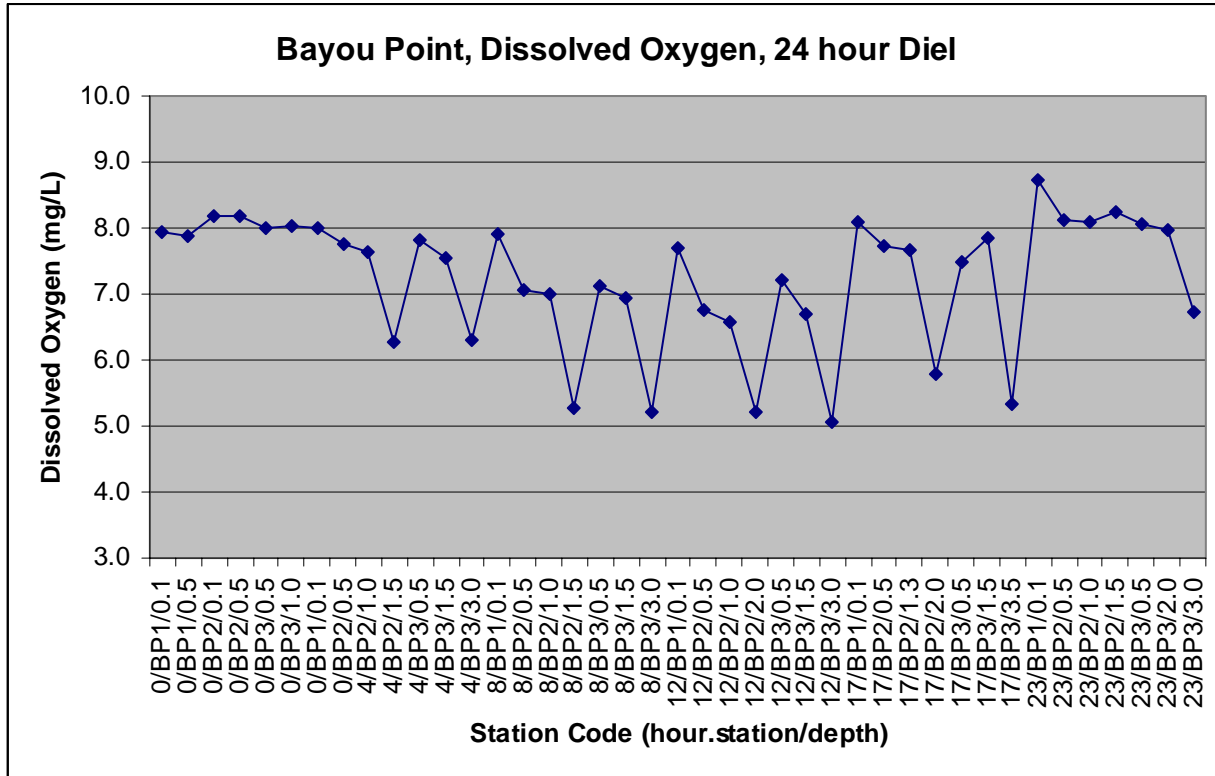
Figure 10: Summary Graph of the seven discrete samplings at all three stations, surface, mid-water and bottom for dissolved oxygen. Stations were sampled at approximate 4 hour intervals for 24 hours. The sample location, arranged chronologically is displayed on the y-axis. The stations code is as follows hour of sampling (0 – 24), station name and depth in meters. The dissolved oxygen is displayed on the y-axis in mg/L. According to 62-302.530, Criteria for Surface Water Quality Classifications, for Class III waters (predominantly marine), dissolved oxygen concentrations must not average below 5.0 mg/L in a 24 hour period and shall never be less than 4.0 mg/L. *These analytical results meet these requirements.*

The profiling data shows healthy dissolved oxygen and that the waters of Bayou Point are quite saline, probably originating in the nearby Gulf of Mexico. The healthy dissolved oxygen values at the three stations imply good mixing and exchange (Table 1). The salinity data indicates minimal fresh water input at this time. There are adequate tidal fluctuations in Bayou Point (Figure 14) an average tidal range of 1.45 feet.

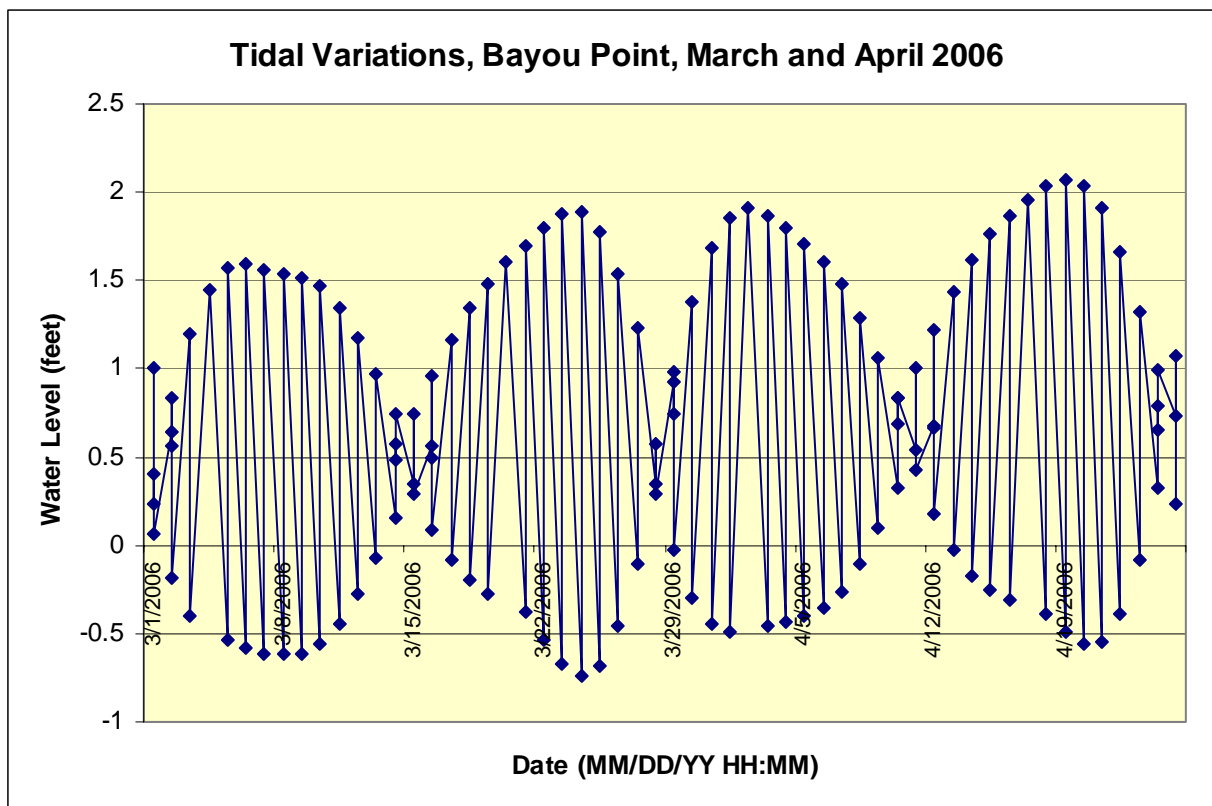
Figure 11: The tidal fluctuations for the months of March and April 2006 at Bayou Point. During this period the average tidal fluctuation in Bayou Point was 1.45 feet.

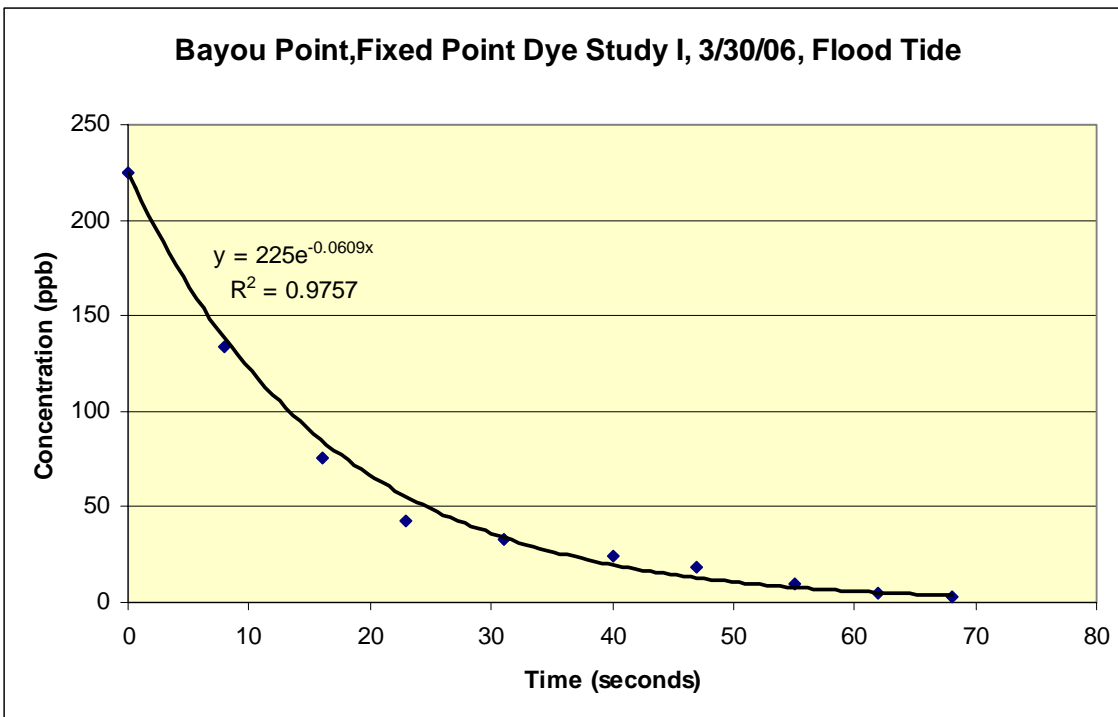
Table 4: Fixed point dye study at station BP-2.

Bayou Point, Fixed Point Dye Study I, 3/30/06, Flood Tide

The 'Fixed Point Dye Study' was performed on an Ebb and Flood Tide on 3/30/06. In both studies the initial concentration of the dye plume was at 10% of its original concentration in less than a minute. Flow was measured at 0.14 to 0.35 feet per seconds. Graphical representations of the data and regressions are depicted in Tables 4 and 5.

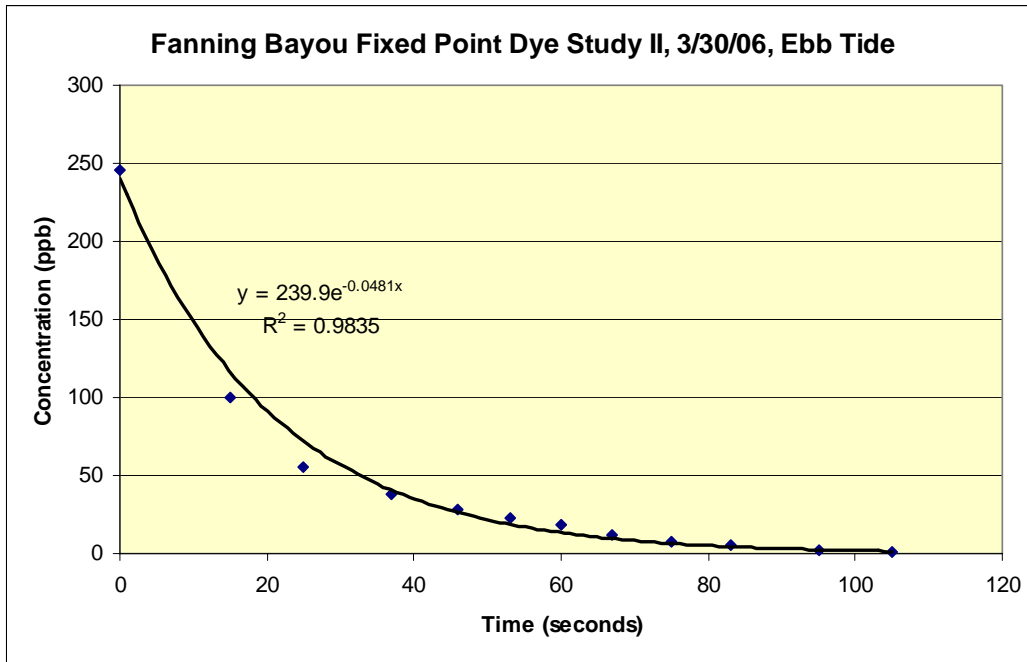
Table 5: Fixed point dye study at station BP-2.

Fanning Bayou Fixed Point Dye Study II, 3/30/06, Ebb Tide

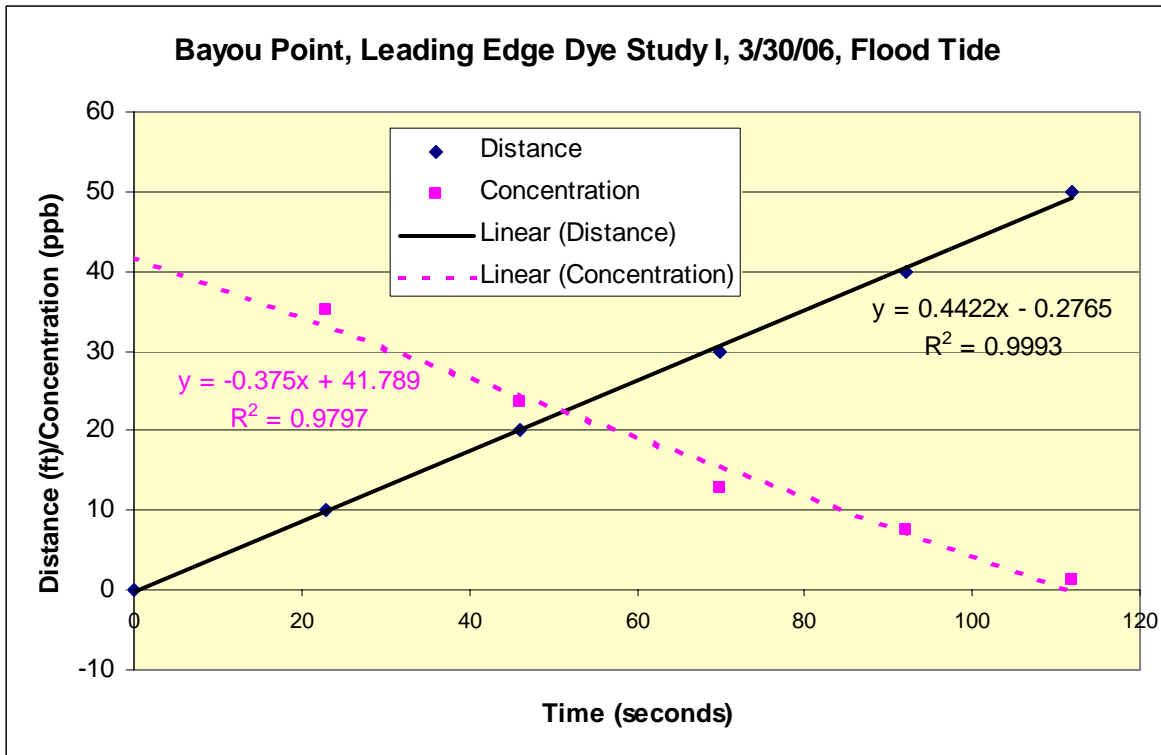
Table 6: Leading Edge dye study at station BP-2.

Bayou Point, Leading Edge Dye Study I, 3/30/06, Flood Tide

A 'Leading Edge Dye Study' was also performed on both Ebb and Flood Tide on 3/30/06. The day was pleasant, approximately 72 degrees F, relatively cloudless and windless until the afternoon. Rhodamine dye was release at the surface of the water near station BP-2. The initial dye concentration was reduced to 10% of its initial concentration in less than 2 minutes. Graphical representations of the data and regressions are depicted in Tables 6 and 7.

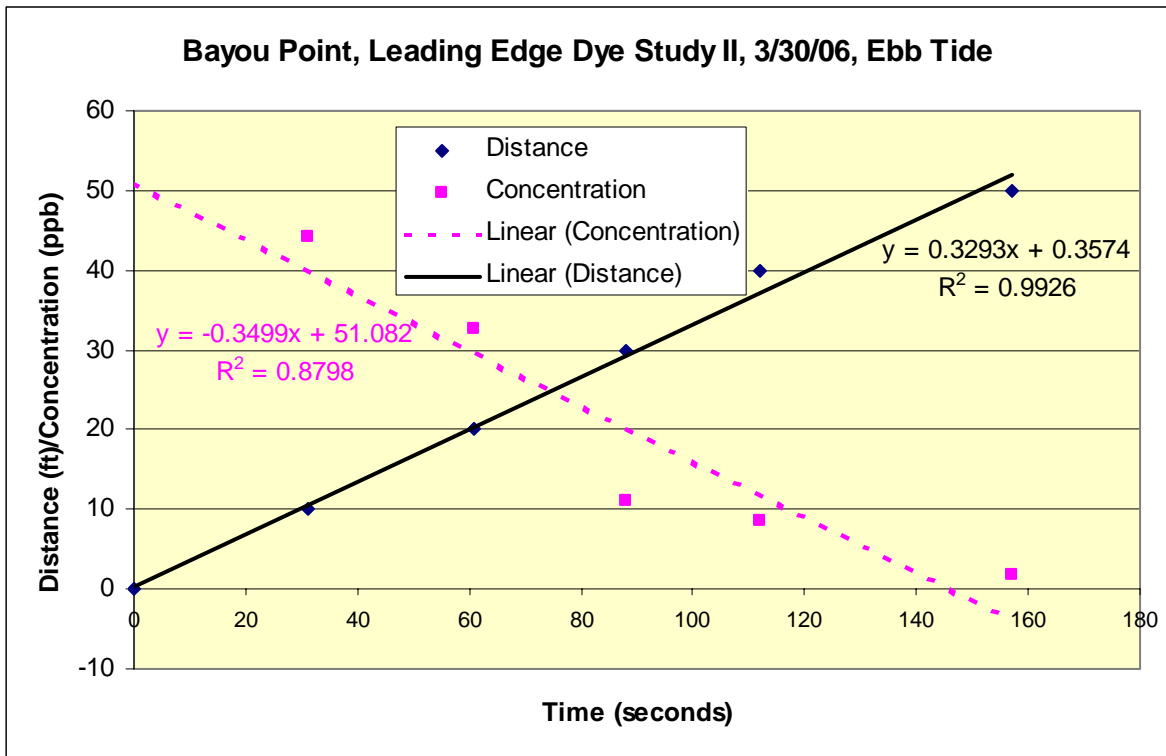
Table 7: Leading Edge dye study at station BP-2.

Bayou Point, Leading Edge Dye Study II, 3/30/06, Ebb Tide

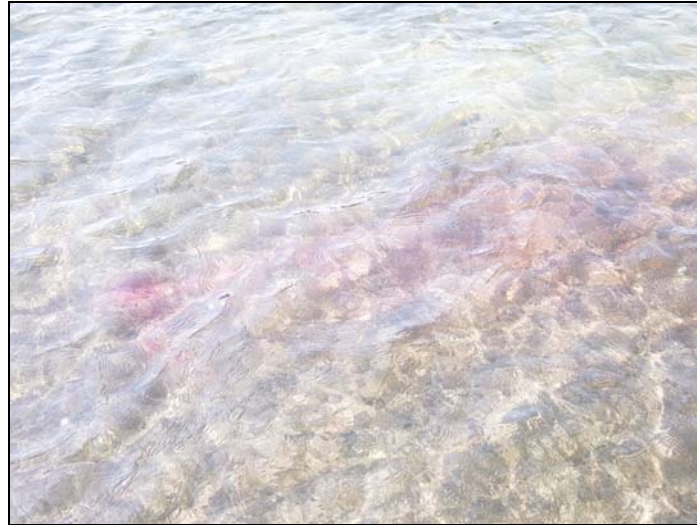
Figure 12: Bayou Point, station BP-2, dye study, 3/30/06, 10 seconds.

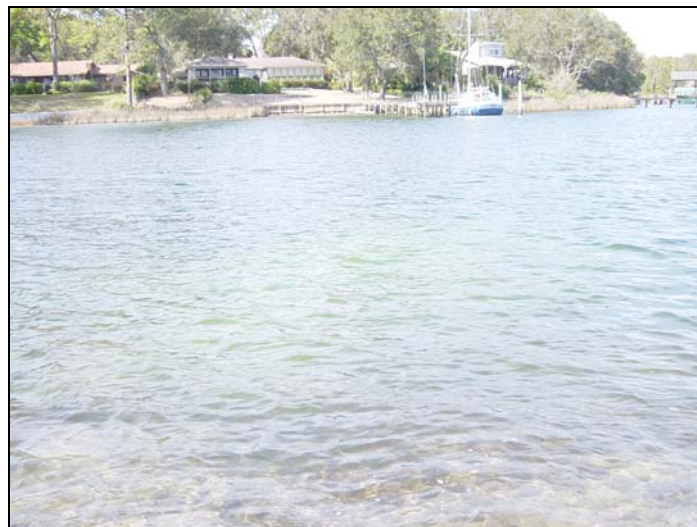
Figure 13: Bayou Point, station BP-2, dye study, 3/30/06, 45 seconds.

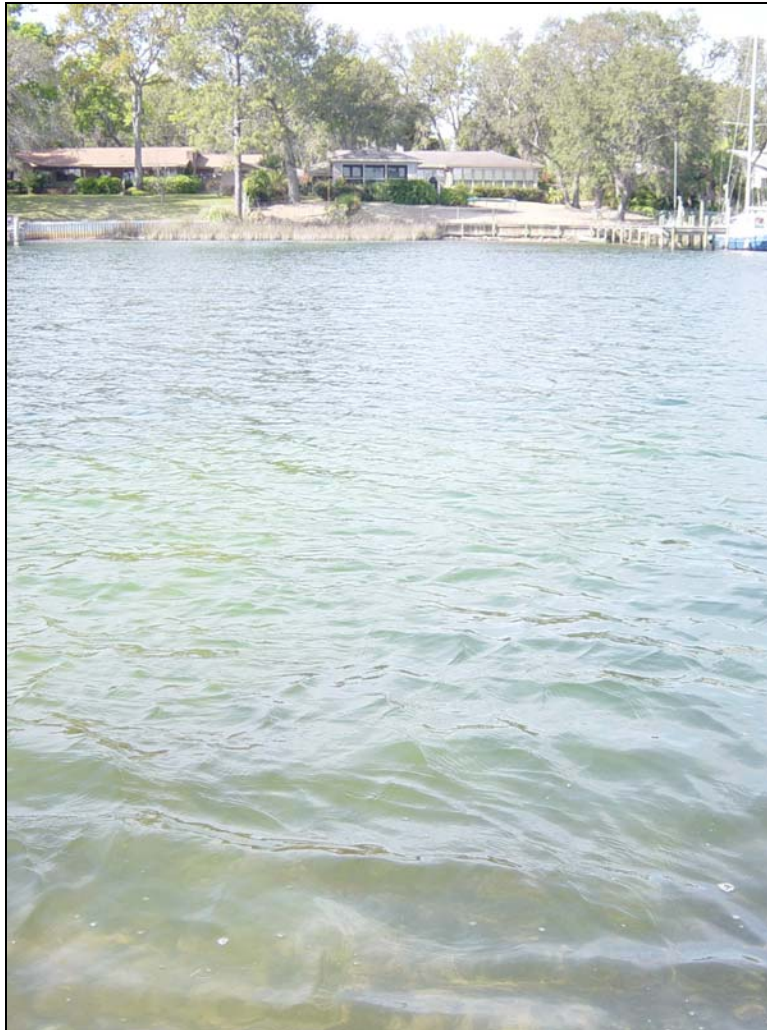
Figure 14: Bayou Point, station BP-2, dye study, 3/30/06, 75 seconds.
